CAUTION: CAREFULLY READ INSTRUCTIONS BEFORE PROCEEDING. NOT LEGAL FOR SALE OR USE IN CALIFORNIA OR ON ANY POLLUTION CONTROLLED VEHICLES.

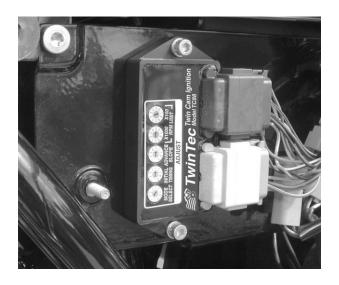
Figure 1 - Typical Installation

- 1. Turn off the ignition switch and disconnect the battery ground cable before proceeding.
- Find and remove the OE ignition module. The OE module is usually located under the seat or under a side cover. You may need to use a small flat screwdriver to press on the connector locking tabs.
- Install the new Twin Tec module. Figure 1 shows a typical installation under a side cover. You can reuse the original mounting hardware.
- 4. Reconnect the battery ground cable.
